The Last 80 Seconds of Flight MP495 on Dec 21, 1992

DFDR and AIDS data analyzed in detail

3 August 2017

AvioConsult

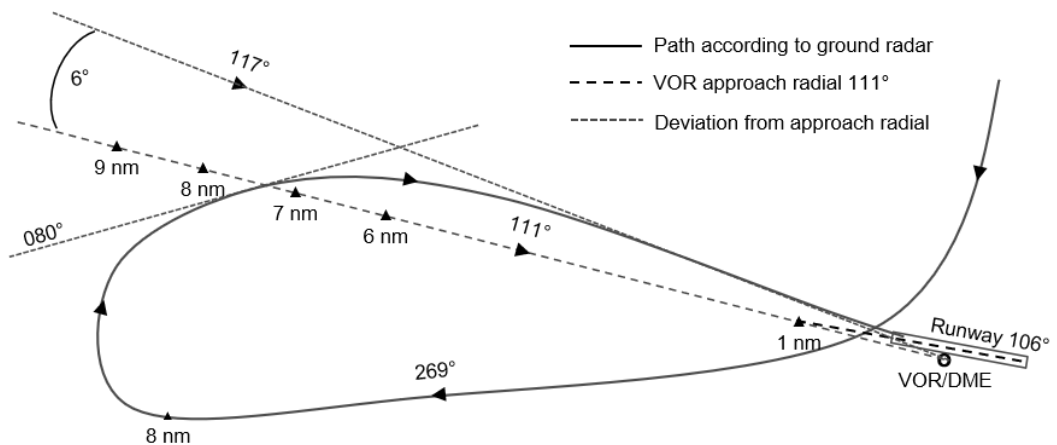
Figure 1. Approach to airport Faro according to Portuguese ATC radar.
Source: Approach chart, Annex 12 Portuguese Report of Accident.

This could have happened with MP495, because the ATC radar data in Figure 1 on page 9 shows a near constant (too) large deviation (6°) from the prescribed approach radial, in which case 117° would have been set as direct to radial. At 3 nm, the HSI indications would have been as shown in the adjacent figure. The heading was 125° (DFDR data), the approach radial set to 117°. This angle was measured in the radar plot in Annex 12 of the RoA, that is copied in Figure 1.

- 5.6.2. **At 500 ft**, the airplane should have flown within 2° of the 111° approach radial for the approach to be allowed to continue; in BIM 3.3.4 – 06 this lateral limit is considered essential. The deviation was much larger (Figure 1) hence, for this reason a go-around should already have been initiated at this time. BIM 3.4.4 – 06 procedures leave no doubt about this, and neither about "basic stability of speed and thrust": "On short or wet runways such factors become of paramount importance. It is therefore strongly recommended that no landing be attempted if the desired stabilization has not yet been achieved when passing 500 ft above threshold elevation". In the same BIM paragraph, approach stability is defined as follows: "Early stabilization on the final approach path with respect to glide path and centre line [$<2^\circ$, RoA § 2.2.3] is considered essential. At not less than 500 ft above threshold elevation this flight path stabilization must also be accompanied by a basic stability of speed and thrust, thus ensuring that any disturbing influences or deviations in the latter stage of the approach can be readily recognized and rapidly corrected".

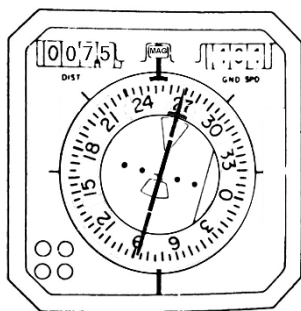
The ATC radar plot in Figure 1 shows that the outbound track was flown quite accurately. DFDR data show that close to the 8 nm point, the airspeed was 170 kt and the heading 252°, proving that a considerable wind correction angle was required at that point ($269° - 252° = 17°$) to compensate for the crosswind component, that must have been approximately 50 kt ($170 \cdot \sin 17°$). A strong wind of which the pilots must have been aware, because they had to manually set the required heading (252°) in the autopilot heading window rather than the outbound radial (269°)

(refer to § 2.5.2). The drift/ wind correction angle was clearly visible, as shown in the adjacent figure. The wind at 8 nm was strong, may be because a thunderstorm was close by.

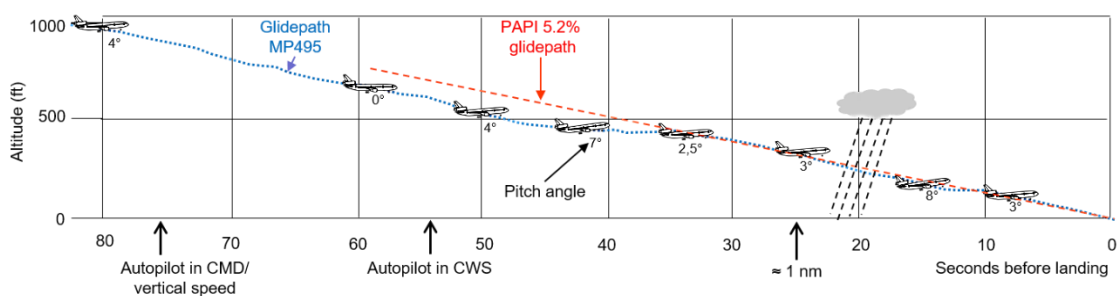
Figure 5. Vertical profile approach MP495, initially in Vertical Speed command mode, from 54 s in CWS. DFDR data.

5.5.2. The DFDR data shows that from 52 s the elevator control input caused the pitch angle to increase from 0° in 10 s time, with a small variation (Attachment 1 (8) and Figure 5). At that instant, the copilot obviously saw both the runway and more red than white PAPI lights and realized that he was below the PAPI glide path (Figure 3 and Figure 5 above). The airplane then maintained level flight for about 12 s (Attachments 1 (9) and 4 (5)) to intercept the PAPI glide path, which occurred at 37 s, after which the nose was pushed down to a pitch angle of 2.5° (Attachment 1 (10)). The copilot even said "PAPI hè" (CVR transcript) to justify the level flight. Until this time, this is normal procedure. The 'maneuver' is the consequence of the

NLR, in RoA Annex 4, explained the maneuver as crossing an area with downdraft, followed by updraft, which was not contradicted by the (pilots of the) DSB. Objective DFDR data however, do not support up- and or downdrafts or windshear; no changes in the light turbulence (Attachment 1 (11)), no lateral accelerations (Attachment 1 (12)), and no sudden in- or decreases of airspeed caused by changes of the wind either, but only small pitch and airspeed changes due to the copilots' control inputs and the 5 kt gust protection by the autothrottle (Attachment 1 (7)).

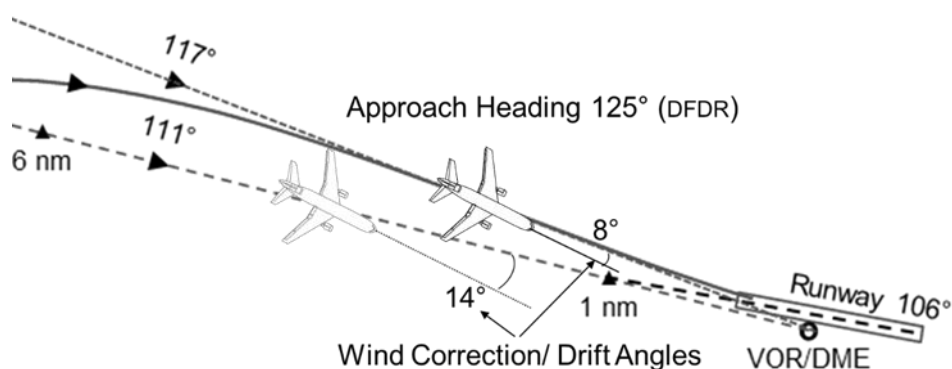
Figure 6. Comparison approach heading 125° (DFDR data) on approach radials 111° and 117° with accompanying drift angles.

- 5.6.4. The magnetic heading was 125° (until 40 s before landing when the pilot-induced side-slips started). The heading of 125° was 14° larger than the 111° VOR approach radial, which is a ground course, as DFDR data shows (Attachment 1 (13)), see also Figure 6 below. A drift angle of 14°, while the airspeed is 139 kt, is quite large and could only be caused by a crosswind component of 34 kt ($139 \cdot \sin 14^\circ$), which is larger than the 30 kt crosswind limit for a landing with a DC-10 on a dry runway (AOM 3.7.1 – 06, see also

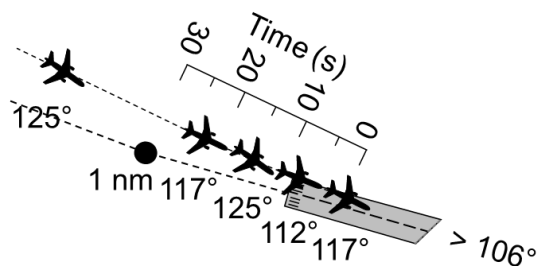
- 5.9.1. **At 33 s**, with about 1.3 nm to go, the copilot again applied left rudder, up to 15% (Attachment 3 ⑤), 7 s later even with two peaks to 30% (Attachment 3 ⑥). The average rudder input was not that large that the heading changed (Attachment 1 ⑭). Attachment 2 ① shows that the rudder peaks are not that large; the yaw damper was also controlling the rudders. In the meantime, the airplane approached the 1 nm point from the runway threshold and could have started to align with the runway thereafter (§ 3.2). This might have been the intention of the copilot by applying rudder input already from 42 s, but then you do not release the rudder under the strong crosswind conditions, but it happened, at 22 s following the second peak (Attachment 3 ⑥). As side effect, and because of a roll control force (Attachment 5 ⑤), the airplane banked 5° to the right (Attachment 3 ⑦), after which the copilot applied left aileron control force to zero bank (Attachment 5 ⑥). The DFDR recorded small rolling movements as side effect of the yawing due to rudder input (Attachment 1 between ⑮ and ⑳), but not a prolonged constant bank angle to the right that would be required to counteract the drift caused by the crosswind and stay above the (extended) runway centerline. These control inputs and airplane motions are not normal if the airplane approaches

on the extended centerline, straight in front of the runway, but support both the conclusion that the airplane approached from the left side on course 117° and the attempt to displace the airplane towards the (extended) runway centerline.

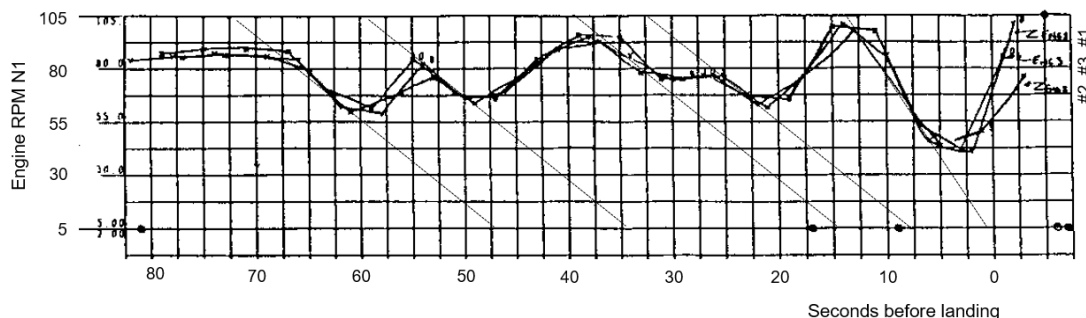
Figure 7. Comparison RPM decrease by autothrottle (4x) and manually by the copilot (1x); this last rate of decrease is larger (DFDR-data, Attachment 1).

- 5.11.1. **At 13 s**, at an altitude of 150 ft, the copilot pulled the throttle handles back to flight idle, with some force against the engaged autothrottles (Figure 7 below). Just prior to this moment, the autothrottle system had increased the RPM of the engines because

the copilot increased the pitch angle (Attachment 1 (18), refer to § 2.3.3 above). One reason for closing the throttles could be that the increased RPM would accelerate the airplane after which the touchdown spot would be further down the (short) contami-

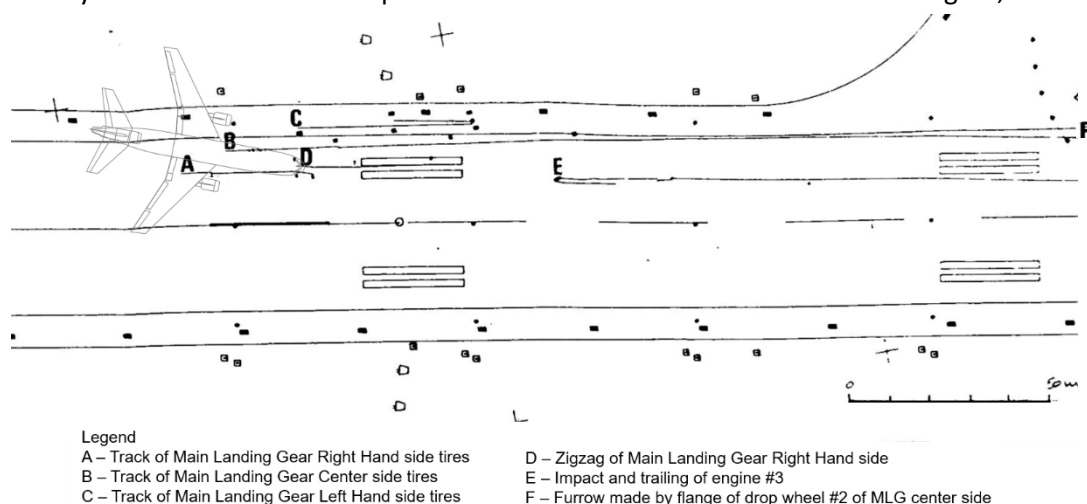
Figure 8. Impact area MP495 on runway 11, RoA Annex 11.

5.13.6. The airplane landed at the point as shown in Figure 8 below, half outside of the runway, with an 11° crab angle to the right, but in the direction of the runway as shown by the scratches A – E. Despite the near maximum rudder to the left during 7 s, and

until 7 s before touchdown, the runway heading was not reached because the airplane did not approach on the extended runway centerline, and the copilot reduced the rudder input to the center, even a little to the right and in the last 2 s of flight more than 50% to the left again, resulting in a rudder deflection of 10° to the left (Attachment 2 (7)). Yawing from the approach heading 125° to runway heading 106° would have taken approximately 10 s, provided the rudder control power would be adequate (refer to § 5.11.4 above), and rudder pedal input would be sustained. The airplane then would have attained the runway heading just 2 s prior to touchdown, which is too late. Hence, the rudder input was too late for alignment with the runway, but had no sense either, because the airplane was not yet above the runway centerline. The control inputs, the point of touchdown and the direction of the traces on the runway prove that the airplane did not approach above the runway centerline.

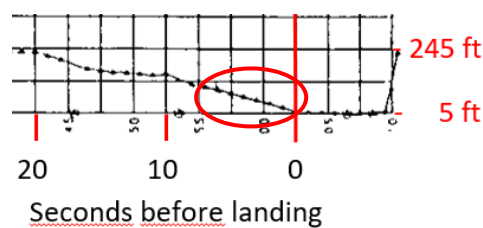
data in Attachment 2, of which a small section is shown in the adjacent figure. As the data shows, the final descent was a straight line; no sign of an increased rate of descent during the last seconds of flight. The final rate of descent was a constant $93/7 * 60 = 797$ ft/min, which is higher than normal, but

within the limits of the landing gear, which were presented by manufacturer McDonnell Douglas in an NTSB report of a similar accident (DCA97MA055). The landing gear survives a rate of descent of 1014 ft/min at maximum landing weight; no damage will occur to the fuel cells in the wings above the landing gear at normal touchdown accelerations up to 2 g.
