The Last 80 Seconds of Flight MP495 on Dec 21, 1992

DFDR and AIDS data analyzed in detail

3 August 2017

AvioConsult

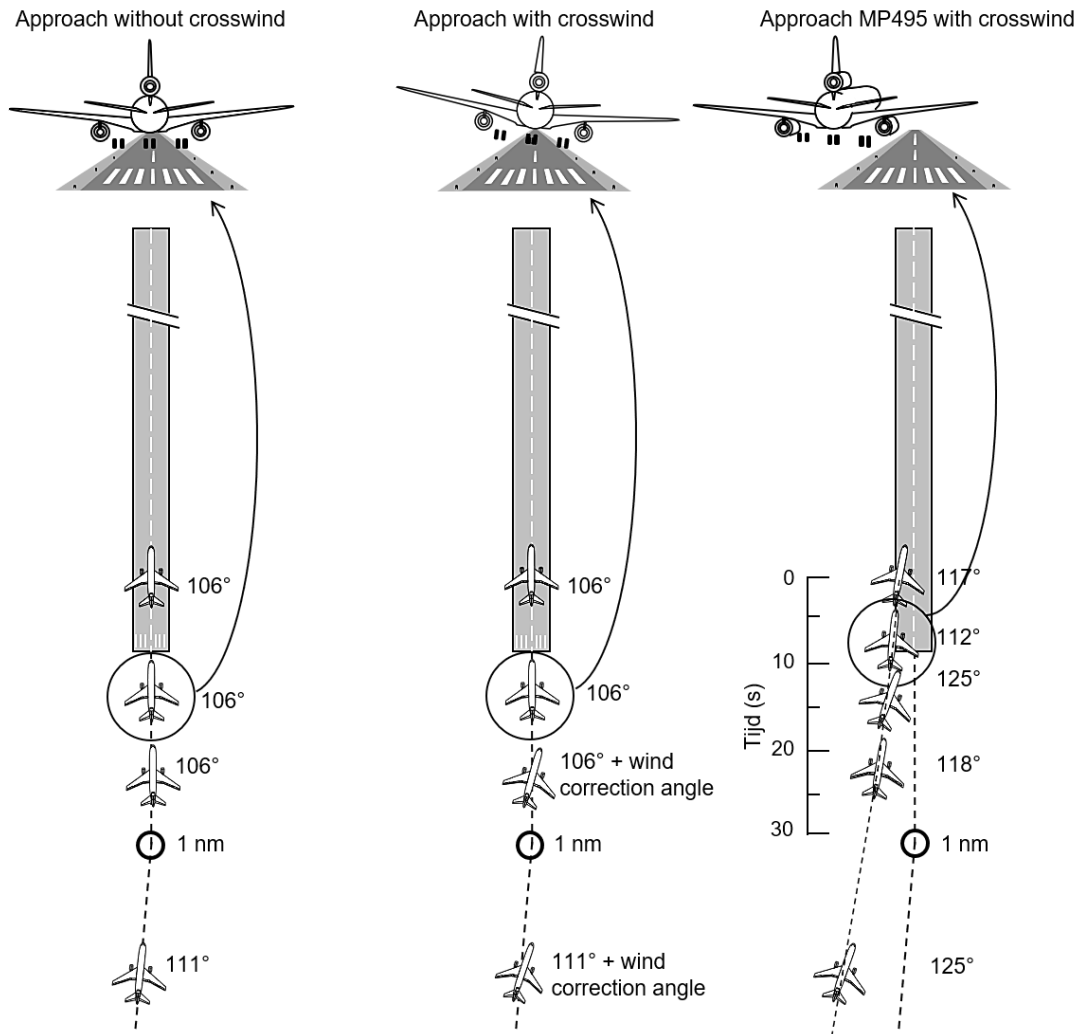
Figure 4. Approach and landing without and with crosswind, and of MP495 at Faro (not to scale). Magnetic heading is shown next to the airplanes.

- 3.2.1. During an approach when a crosswind is present, a wind correction angle is required to prevent the airplane from drifting away from the 111° approach radial and from the extended runway centerline. This is shown in Figure 4 below, center. The wind correction angle depends on the magnitude of the crosswind component. As an example, with a 90° crosswind component of 15 kt and an airspeed of 139 kt, the wind correction angle is 6° ($\sin^{-1}(15/139)$); when the crosswind component is 30 kt, being the maximum approved for a DC-10 on a dry runway (AOM § 3.7.1 – 06), the angle is 12°. In crosswind conditions, the small offset correction of 5° is also required to establish

- 5.11.3. Not maintaining adequate roll control input to the right, against the crosswind, at the same time as the large rudder input to the left, is also an indication that the airplane was not above the (extended) runway centerline, but still to the left of the runway. The airplane was side slipping to the runway from the left side, as shown in Figure 4 right side.

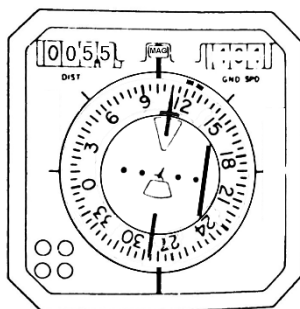
- 4.1.4. At 7 nm, the airplane not only had to be established on the approach radial, but also be configured for landing, i.e. the landing gear is down (at 9 nm), the flaps and slats are selected (at 8 nm) and the airspeed is the required approach speed (§ 2.3.3 above and AOM 3.3.5 – 06). The CVR transcript proves that the airplane was configured for

landing too late. At 7.5 nm, the vertical speed should be set in the autopilot, such that the descent indeed begins at 7 nm. The descent will be further analyzed in § 5 below. At 5.5 nm, the display of the HSI could have been as shown in the adjacent figure. The heading set on the autopilot is 125°, the approach radial is set to 111° and the magnetic heading at this instant is 100°. The course deviation bar is maximal right to indicate that the heading needs to be increased (to $111^\circ + 30^\circ = 141^\circ$) for intercepting the 111° approach radial at an angle of 30°. This did not happen.

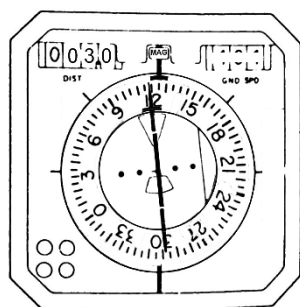
- 4.1.5. Both the ATC radar data in Figure 1 and the analysis in § 5 below prove that no course correction was applied to return to the 111° approach radial, while this is required for the approach to be stabilized, as required in BIM 3.4.4 – 06 and AOM 3.3.5 – 11. The angle between the airplane position and the approach radial at 500 ft altitude may not exceed 2° (1 dot), but was for MP495 even 6° that cannot even be displayed on the HSI. The course deviation bar must have been all the way to the right side as shown in the figure in the next paragraph. The pilot cannot only set the required approach radial on the VHF NAV Control Panel (Figure 2, item 1), but also adjust the course (CRS) knob until the course deviation bar of the HSI is in the middle, to be able to navigate direct to the VOR/ DME from the current airplane position.

This could have happened with MP495, because the ATC radar data in Figure 1 on page 9 shows a near constant (too) large deviation (6°) from the prescribed approach radial, in which case 117° would have been set as direct to radial. At 3 nm, the HSI indications would have been as shown in the adjacent figure. The heading was 125° (DFDR data), the approach radial set to 117°. This angle was measured in the radar plot in Annex 12 of the RoA, that is copied in Figure 1.

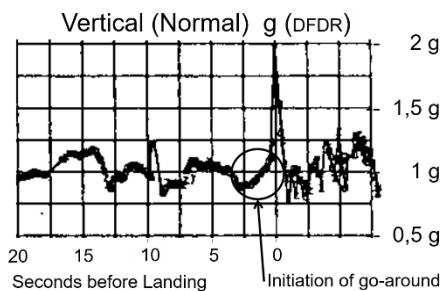
- 5.13.1. During the last seconds of flight, the pitch angle was increased to 9°, with a dip at 2.5 s because the pilot did not maintain control column input up (Attachment 4 (8)) while

the throttles were pushed forward, both for the go-around. These control inputs, including the dip, are shown by the graph of the vertical acceleration (Attachment 1 (28)), of which the relevant part is shown in the adjacent figure. The graph proves that the airplane was not pushed down by a downdraft during the last 2.5 s of flight but that, on the contrary, the descent must have reduced because of the re-

sponse of the airplane to the elevator-up control input for the go-around (Attachment 2 (9)).

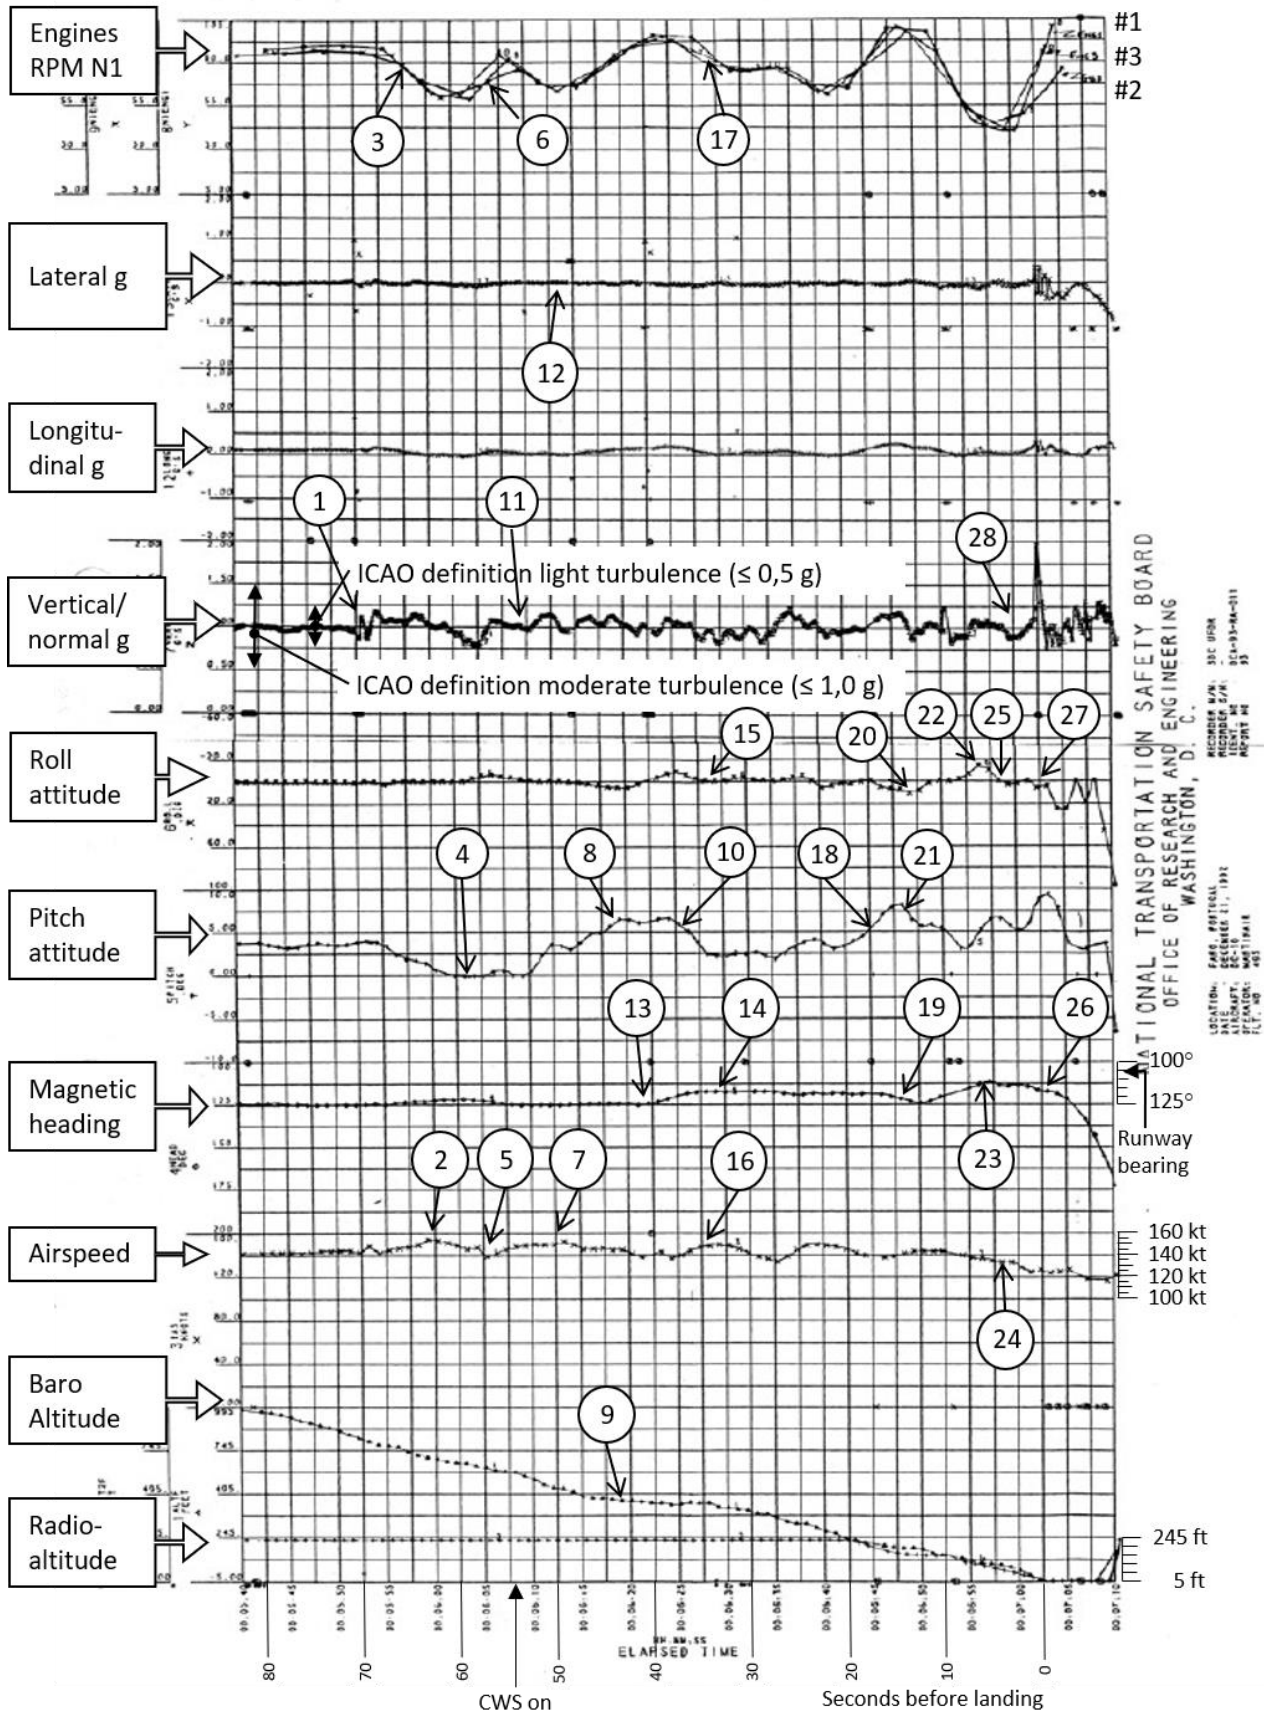
Attachment 1. Page 1 out of RoA, Annex 15. Part of DFDR Factual Report NTSB

NLR, in RoA Annex 4, explained the maneuver as crossing an area with downdraft, followed by updraft, which was not contradicted by the (pilots of the) DSB. Objective DFDR data however, do not support up- and or downdrafts or windshear; no changes in the light turbulence (Attachment 1 (11)), no lateral accelerations (Attachment 1 (12)), and no sudden in- or decreases of airspeed caused by changes of the wind either, but only small pitch and airspeed changes due to the copilots' control inputs and the 5 kt gust protection by the autothrottle (Attachment 1 (7)).

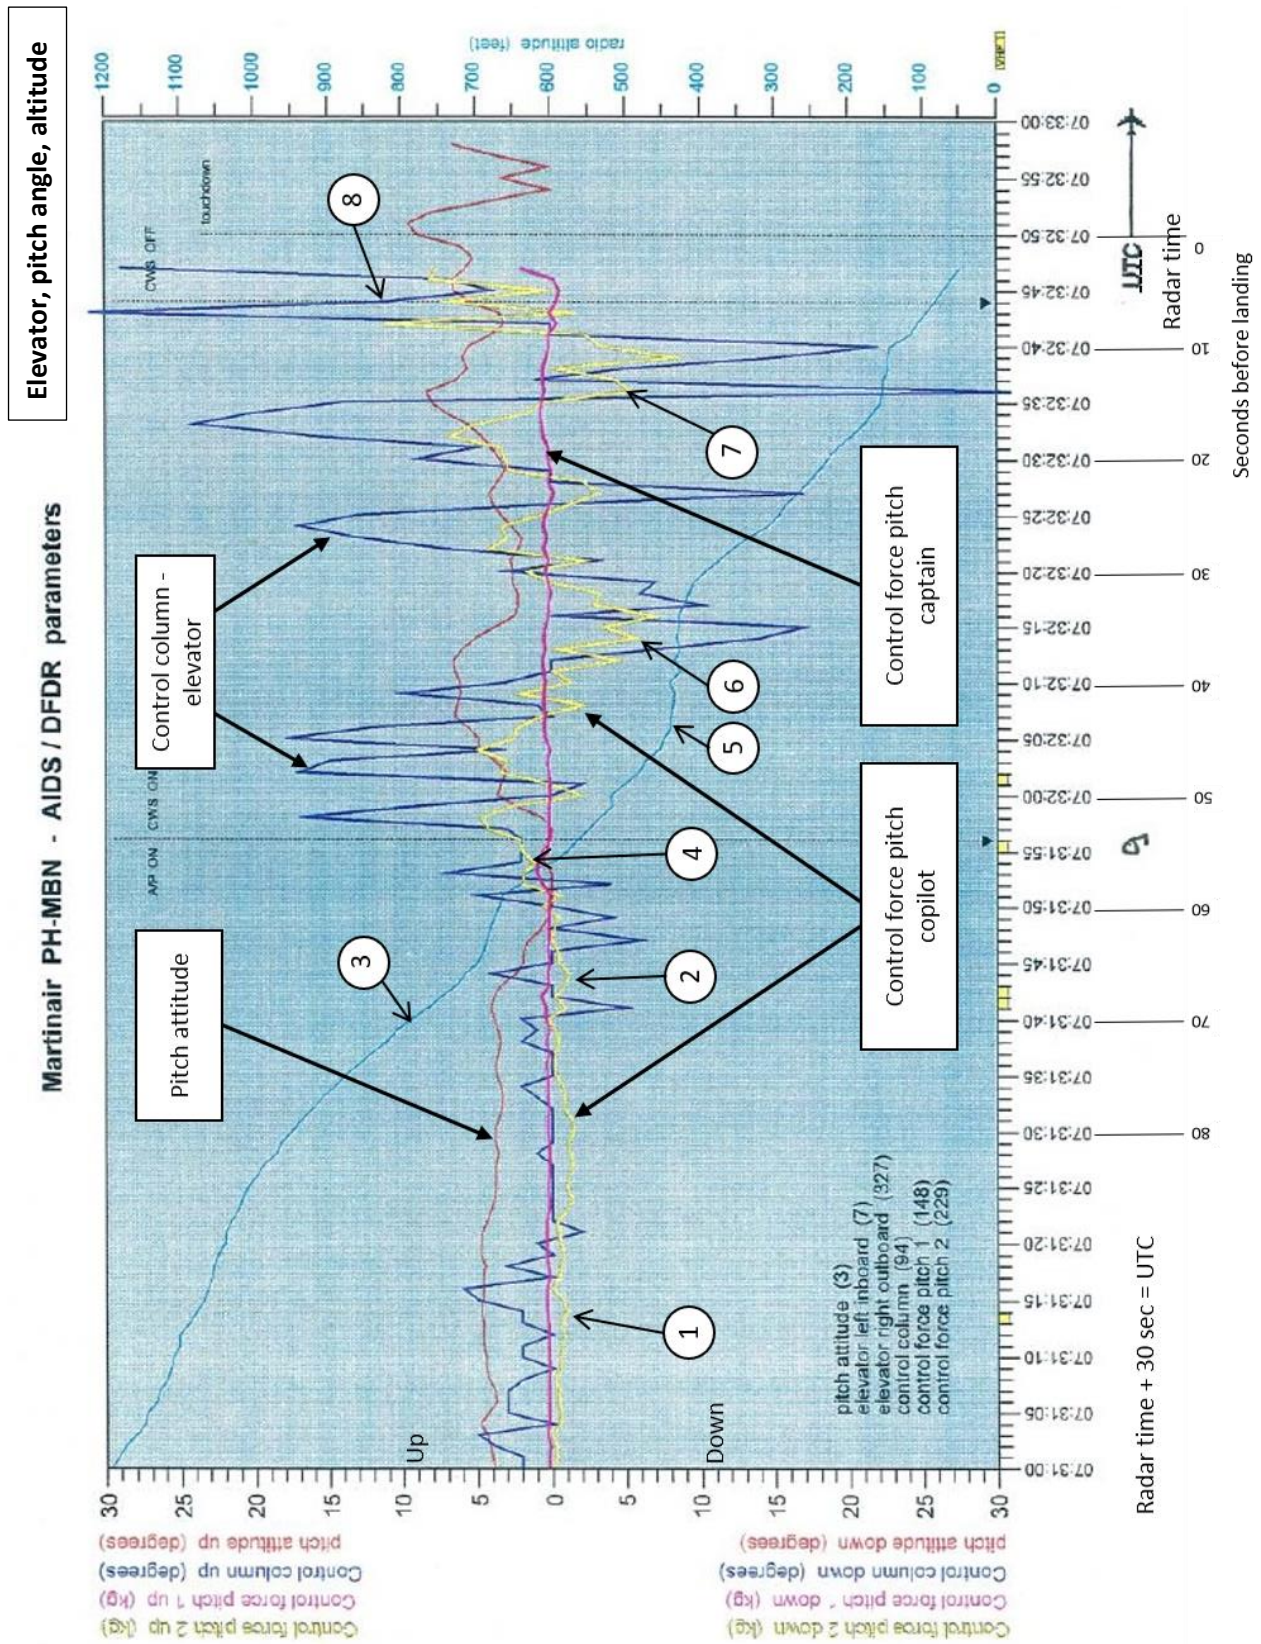
Attachment 4. Graph 9 out of RoA, Annex 9, AIDS data. Elevator, pitch angle, altitude

5.2.2. The AIDS control column pitch force graph in Attachment 4 (1) also shows that the copilot at that time pushed the elevator control up to 1,5 kg¹, in fact against the autopilot that was engaged to control the descent. A little pressure is normal, because the hands are loosely resting on the controls, also when the autopilot is engaged (during the approach); the control wheel and column move with the control surfaces as tactile feedback of the autopilot to the (human) pilot-flying (§ 2.6.1).
